# HOME INSPECTION REPORT

206 Howard Park Ave  
Toronto

Inspection Date: [June 17 2025](#)

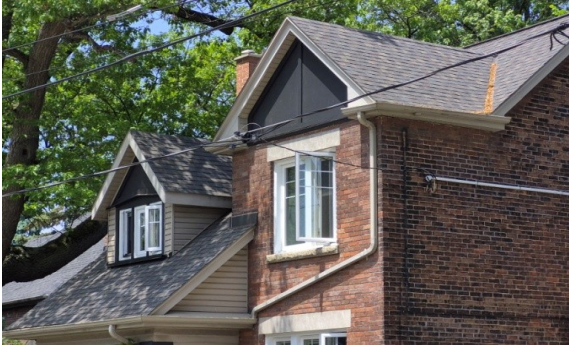
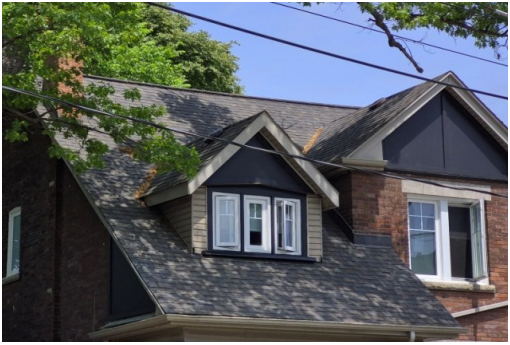
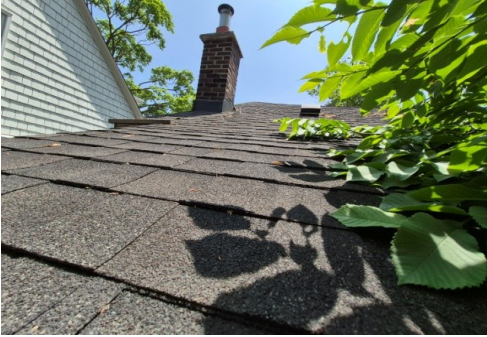
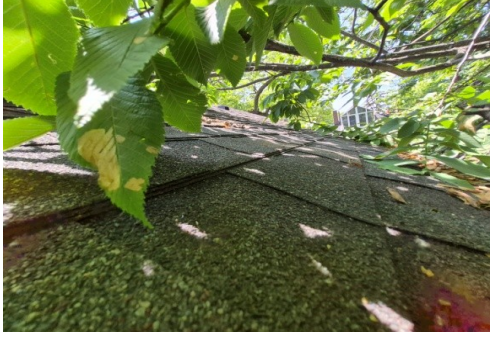
| <p>Tree Branches: <a href="#">retain arbourist for annual monitoring/trimming</a><br/> <a href="#">presently requires trimming at rear</a></p> <p>Sloped Surface: <a href="#">overall surface in good repair</a></p> <div style="display: flex; justify-content: space-around;"> </div> <div style="display: flex; justify-content: space-around;"> </div> <p>Chimney(s): <a href="#">overall in good repair</a></p> | | | |

| <p>Note: <a href="#">Recommend Annual Maintenance Contract for Roof Surface, Flashing Details and Chimney(s)</a></p> | | | |

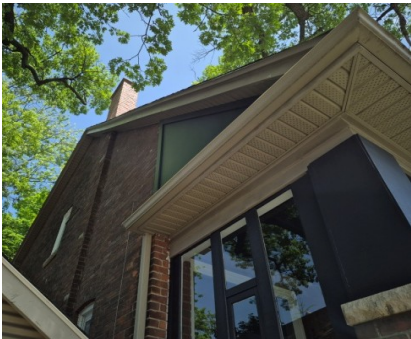
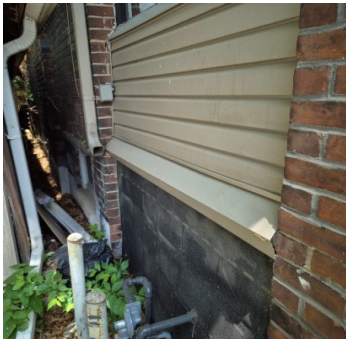
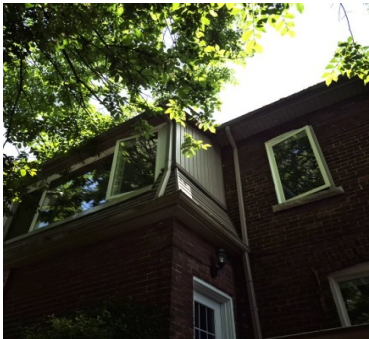
| <p>**Gutters/Downspouts: requires maintenance/cleaning, including roof valleys<br/>extend 6-ft away from house</p> <p>WALL SURFACES: overall in good repair</p> <p>DOORS/WINDOWS: overall in good repair, general painting to wood components as required</p> | | | |
| PORCH overall in good repair<br><br>DECK overall in good repair | | | |

| Note: Maintain Gutters & Downspouts annually. Extend Downspouts at least 6-feet away from the house<br>** Any or all these items may contribute to <b>Basement Leakage</b> . Please see Interior Page | | | |

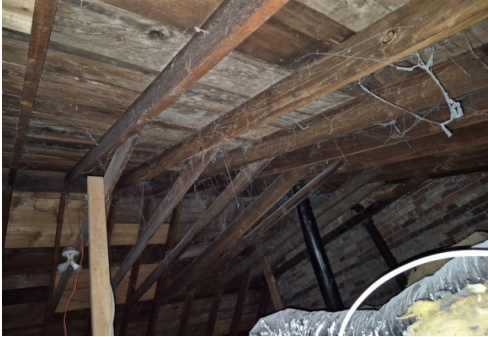
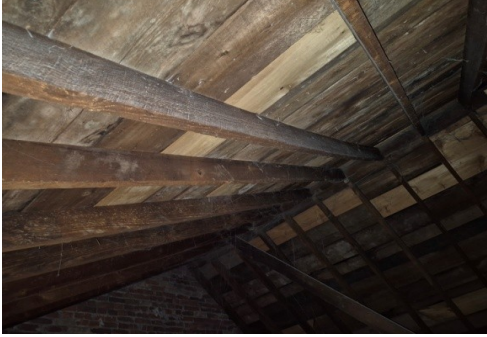
| <p>overall well built house</p> <p>ROOF: overall in good repair<br/>prior repairs noted to some planks,<br/>staining at underside typical for age of house</p> <div style="display: flex; justify-content: space-around;"> </div> | | | | |

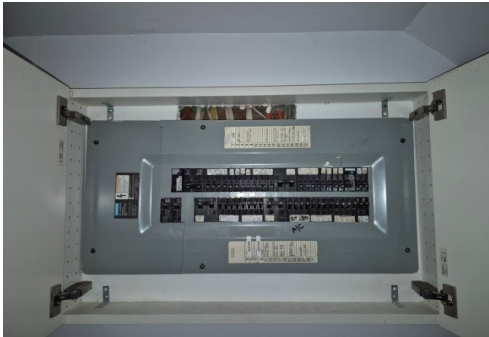
| <p>SERVICE ENTRANCE: overall in good repair</p> <p>SERVICE PANEL: overall in good repair</p> <p>panel access obstructed by furniture - cover not removed</p> <div></div> <p>BRANCH WIRING: random sampling determined the wiring has been upgraded throughout</p> <p>Junction Box(es): basement: exposed wires - provide covers</p> | | | |

| Note 1: All recommendations are safety issues - Treat them as high priority. | | | |

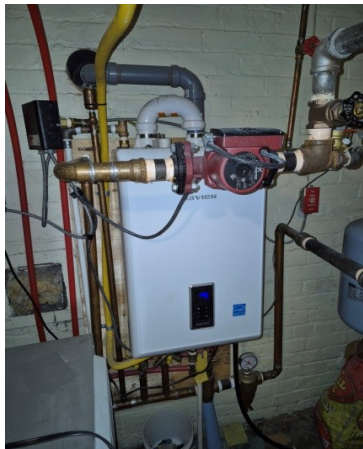
HOT WATER BOILER: service annually  
COMBINATION SYSTEM: provides house heating and domestic hot water

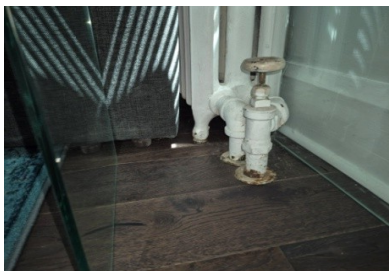
Radiator(s): overall in good repair, many newer valves  
monitor corroded piping/valves and repair as required

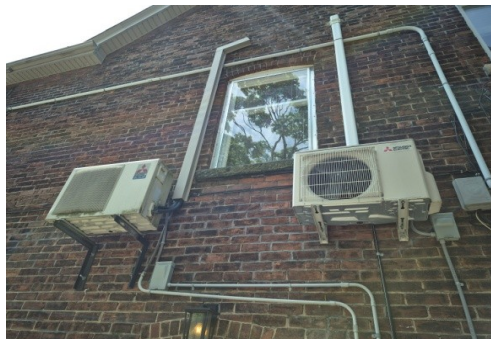
| <p>DUCTLESS A/C: two units: service annually</p> <div></div> | | | |

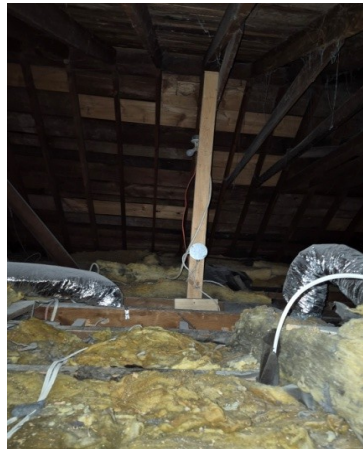
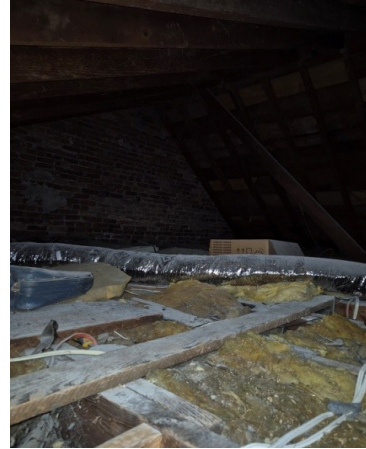
ROOF SPACE: various gaps and low amount of insulation should be improved  
remove debris, secure wires properly  
appears abandoned ducts in roof space

Roof Access Hatch: insulate and weather-strip access hatch to roof space

Ventilation: recommend improving ventilation with soffit vents
